Grass River Natural Area Stream Monitoring Report
January 2016

Prepared by
T. A. Clement *MSc*

Sponsored by Grass River Natural Area

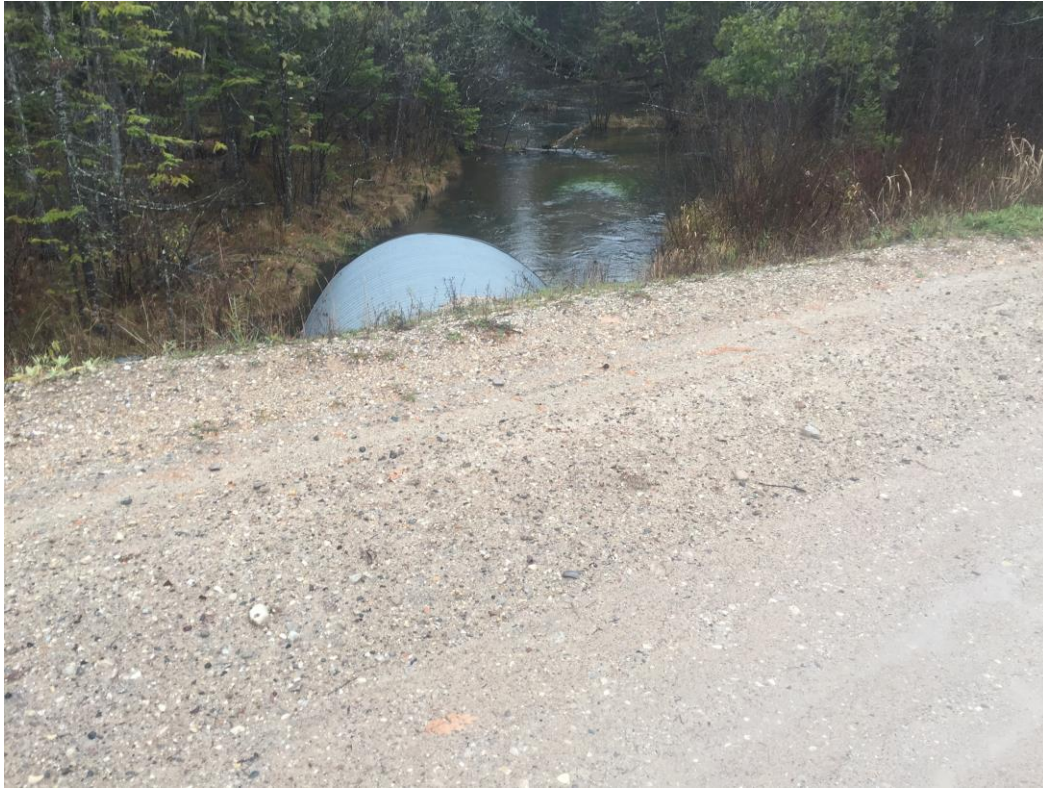
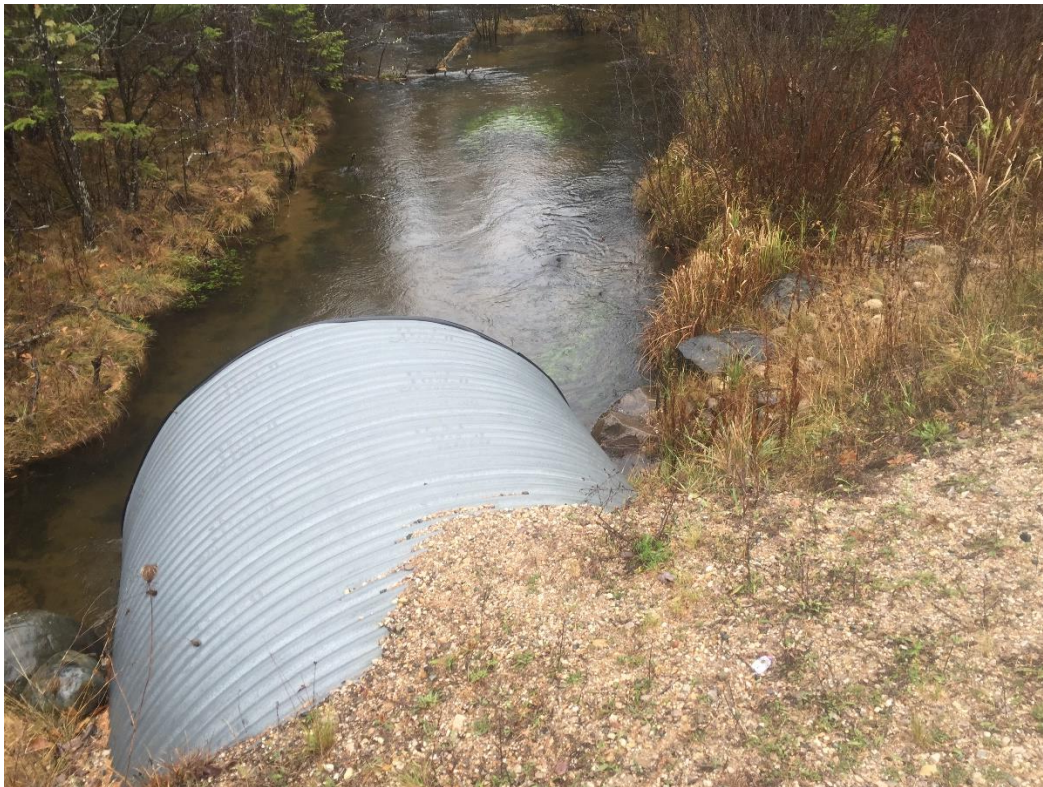
This site had more visible erosion but it was mainly near the road crossing. The road crossing consists of a large culvert surrounded by stone and sand (Figure 2 & 3). The culvert is likely undersized for this crossing. Undersized culverts tend to hold water back on the upstream side causing stream widening on either side of the culvert. This widening increase the sediment load coming from the road crossing. The small culvert also increases water speed through the culvert that can cause scouring effects and increased bank erosion on the downstream side of the culvert. There were also visible areas of erosion on both the upstream and downstream sides of the culvert caused by road runoff. The embeddedness in this area was also high, however the area within the culvert was mostly free from sand and contained only small rocks which may prove a viable spawning habitat for fish. Other than the areas immediately adjacent to the road crossing, the riparian habitat was relatively un-impacted and had significant wild growth on each side of the stream.

Figure 2. The upstream side of the Tyler road crossing on Cold Creek. You can see the culvert with no “bank” to prevent road material from washing into the stream. This culvert is likely undersized causing bank erosion and stream widening

To assess the stream crossing issues I would look for funding to remediate and improve these crossings. The first crossing remediation I would attempt would be the Finch Rd crossing. This crossing blocks fish passage both upstream and downstream which limits not only livable habitat but also higher quality spawning areas. This road crossing is also widening the stream and causing increased sediment load for downstream areas. Next on the list would be the Tyler Rd crossing as it is likely a large source of sediment running into Cold Creek.

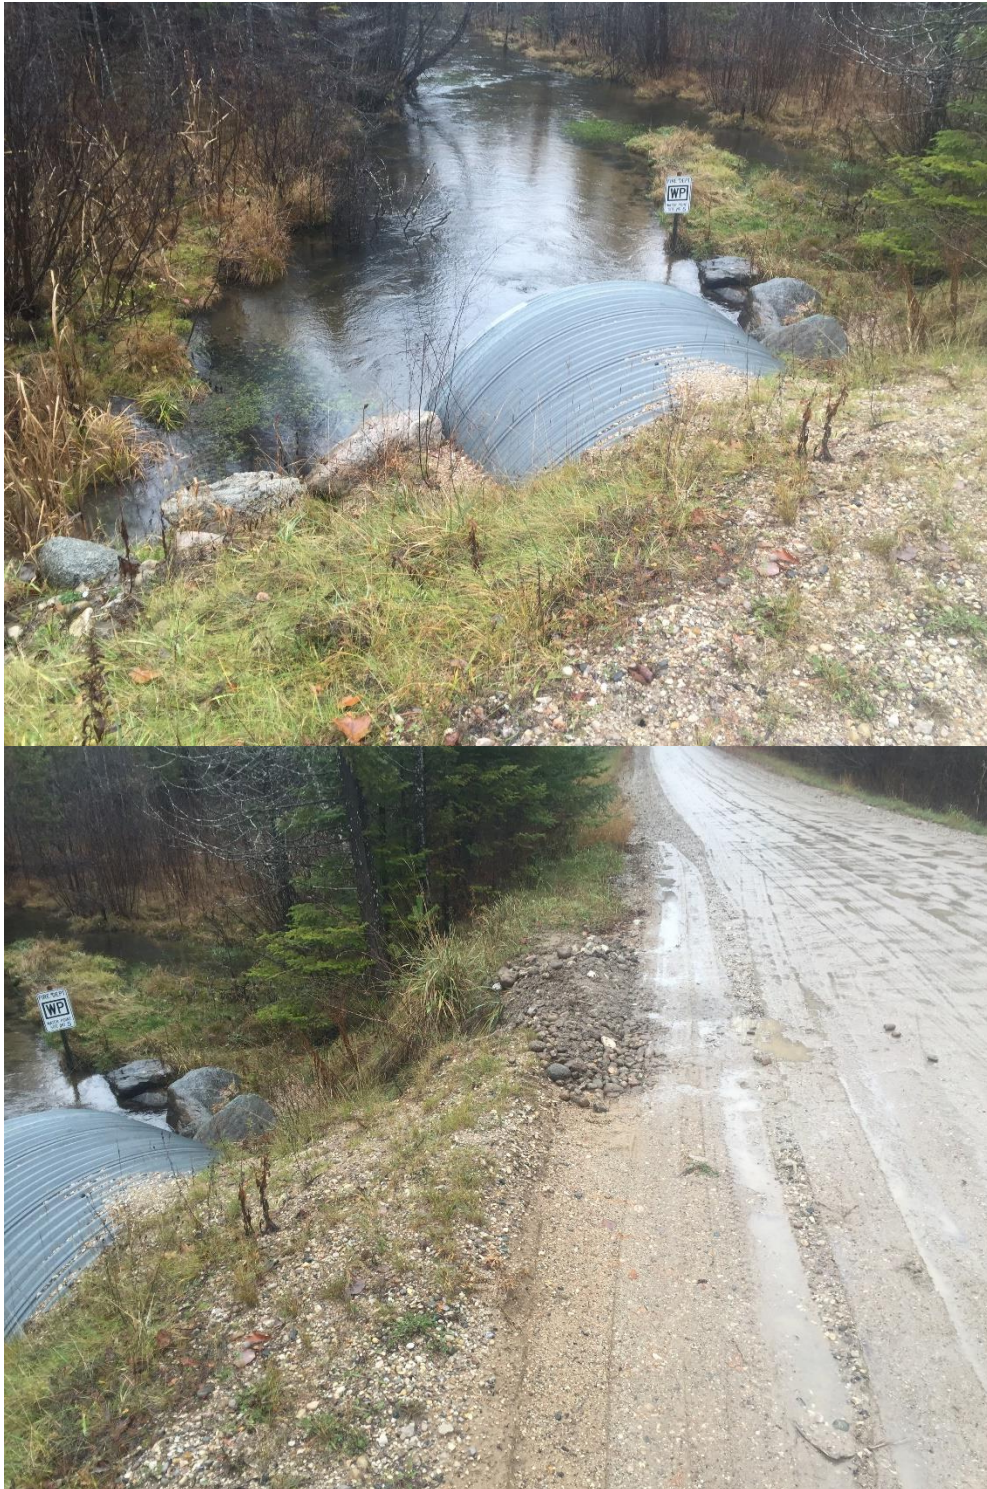
Figure 3. The downstream side of the Tyler road crossing. In the second photo you can see where the road had washed out and was “fixed” with more stone. These wash out events can increase sediments loads far greater than typical sediment loads of poor quality road crossings

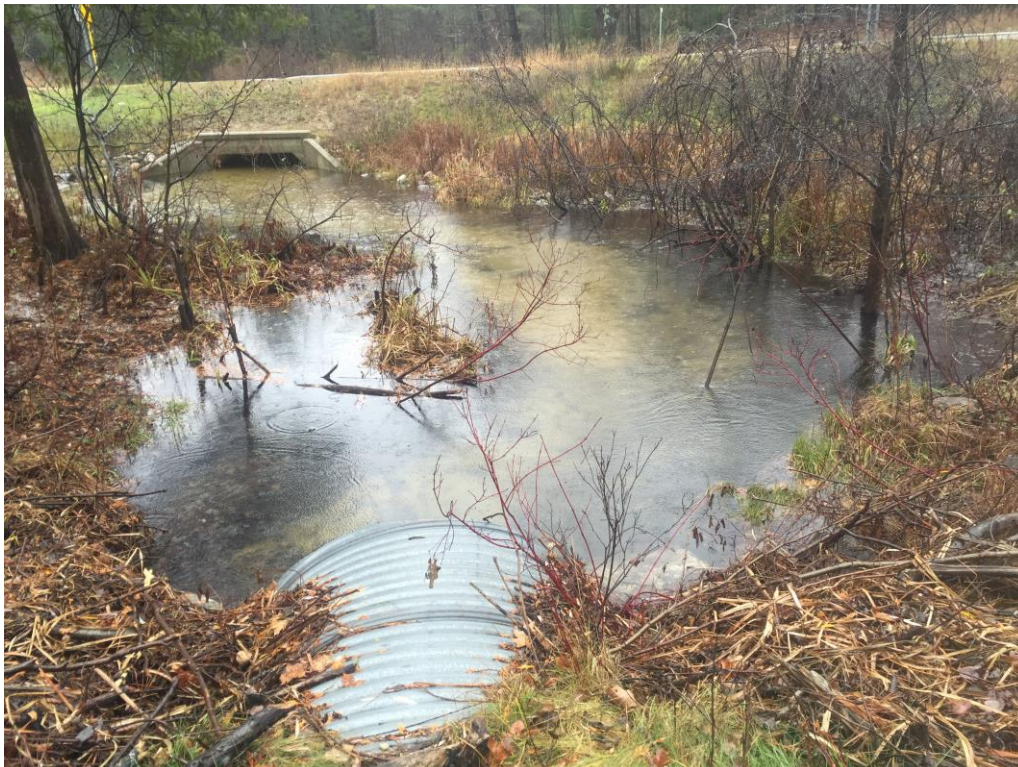
This site on Shanty Creek had relatively high sedimentation rates, high embeddedness and relatively poor cover. The increased sedimentation rates here are likely due to the increased runoff from the road crossing along with a limited buffer zone adjacent to the stream (Figure 4). Once away from the road crossing, the more natural riparian zone increases in both width and denseness of natural vegetation.

Figure 4. Upstream side of the Grass River Rd crossing. The farthest structure upstream is the M88 Crossing of Shanty Creek. This picture was also taken during a rain event and the stream is pushing into its flood plain

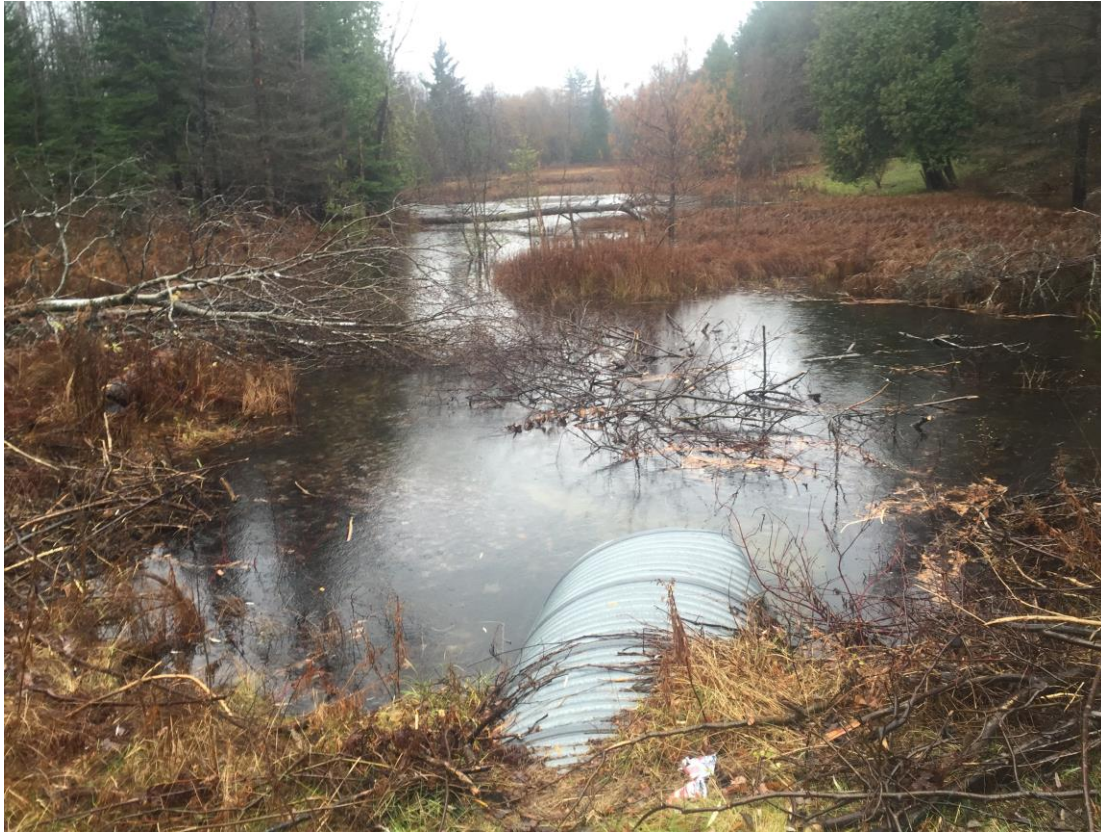
Figure 5. Downstream side of the Grass River Rd crossing. Again, the river is starting to push into its flood plain during the recent rain event

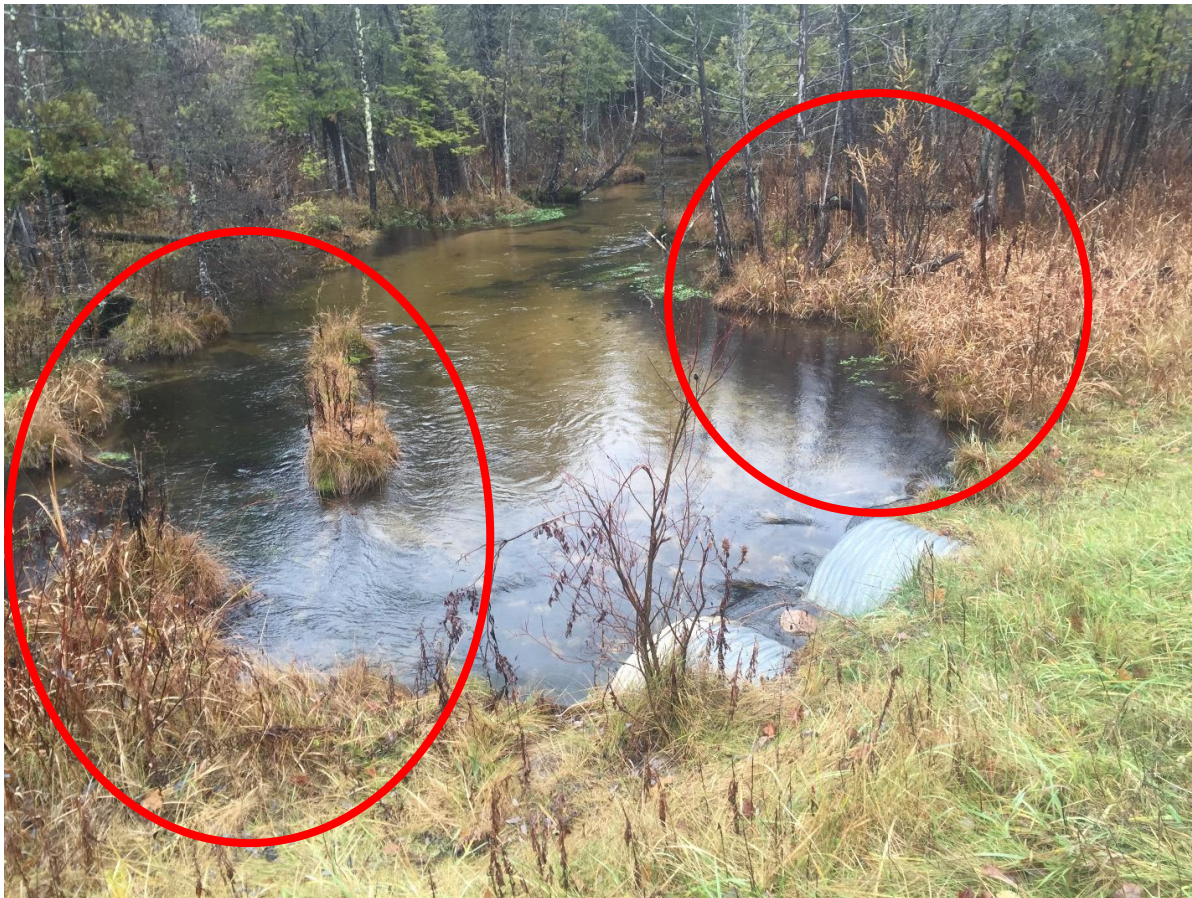
This site had good instream cover, and downstream of the culvert there was lower embeddedness and good riffle habitat. However, the undersized and perched culverts make this a site prime for remediation. The undersized culverts have caused water to back up and form eddies upstream of the culvert, which widens the river and increases sediment load downstream. You can see this on both sides of the stream bank circled in red (Figure 6). The eddies that form also allow for the settling of sediments that would otherwise be washed downstream. The downstream side of the crossing is not only perched but also has a increased rate of flow that increases bank erosion and stream widening due to the culvert being incorrectly sized (Figure 7). The perched culvert prevents fish, in this case both brown and brook trout, from moving upstream. The riparian zone along the downstream side of the road is more disturbed with only a few cedar and pine trees and mostly grasses (typical of lawn species) to the edge of the stream.

Figure 6. The upstream side of the Finch Creek Rd Crossing of Finch Creek. Backwash eddies causing stream bank widening and increased sediment load
